October 2, 2008  
WP Project No. OHTB08

Subject: Visual Observations of House at 173 Highland Avenue, Gardiner, Maine

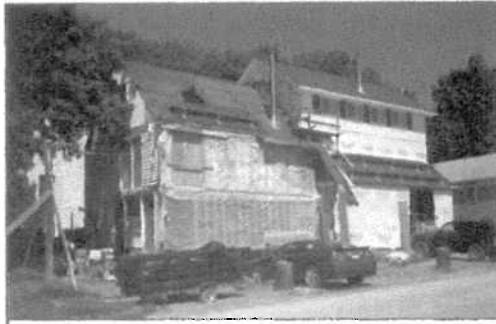
- The plywood siding has been removed from a large portion of the front of the house. The exposed wood studs are covered by either plastic sheeting or "Tyvek" home wrap. Please refer to Photos 1 and 2 for a view of this area.  
*This wall may be unstable without the plywood and not offer the proper required lateral strength if the house is subjected to either wind or seismic loads.*

Photo 1 - View of house from Clinton Street

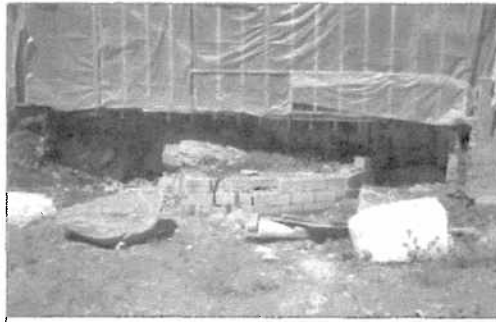
- The southeast portion of the house is unsupported as follows:
  - The ends of the first floor framing joists at the southeast end of the house are not supported. Please note that the east side wood stud bearing walls are directly supported by the joists at this location so the walls are also unsupported. There appears to be several steel lally columns under the floor, about 3 feet from the joist ends. However, it is questionable whether pipe columns are providing adequate support for the floor joists and whether the columns are properly supported from the ground below (it appeared that one of the columns was only partially bearing on an outcrop of ledge). Please refer to Photo 2 for a view of this area.  
*This portion of the building appears to be unstable and is in danger of movement that could be easily triggered from the normal use of the house, a heavy wind or seismic event or buildup of snow on the roof.*

Photo 2 - Unsupported first floor framing

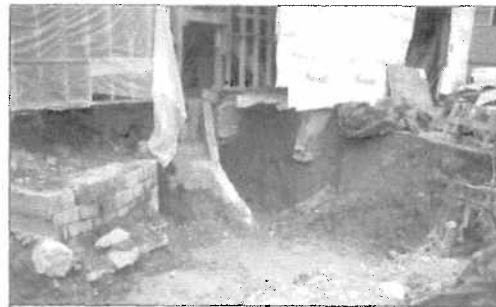
- There is a large excavated hole in the front of the house extending north from the southeast corner of the building to the edge of the driveway and east to Clinton Street. Several vehicles and pieces of construction equipment are parked in the driveway adjacent to the hole. The hole is about 8 feet deep. The excavated hole has very steep edges adjacent to the driveway and below the damaged foundation (see discussion of this issue below). Please refer to Photo 3 for a view of this area.  
*This excavation should be shored or cut back to a more appropriate sideslope based on the type of soils. There is potential danger that the walls of the excavation could collapse, especially if a heavy rain or seismic event occurs. If the excavation collapses, this could trigger either movement or settlement of the house.*

- Most of the foundation wall on the east side of the house has been exposed and it appears that several portions of the foundation have been removed. In addition, a portion of the exposed foundation at the garage has been undermined by the excavated hole in front of the house. It appears that a portion of the wood bearing wall in this area is unsupported. Please refer to Photo 3 for a view of this area.  
*This portion of the building appears to be unstable and is in danger of movement that could be easily triggered from the normal use of the house, a heavy wind or seismic event, a buildup of snow on the roof or movement of the remaining soil below.*

Photo 3 - Excavated hole and exposed foundation
