# Gardiner Stormwater Assessment Project

Hoyle, Tanner  
& Associates, Inc.

# Project Scope

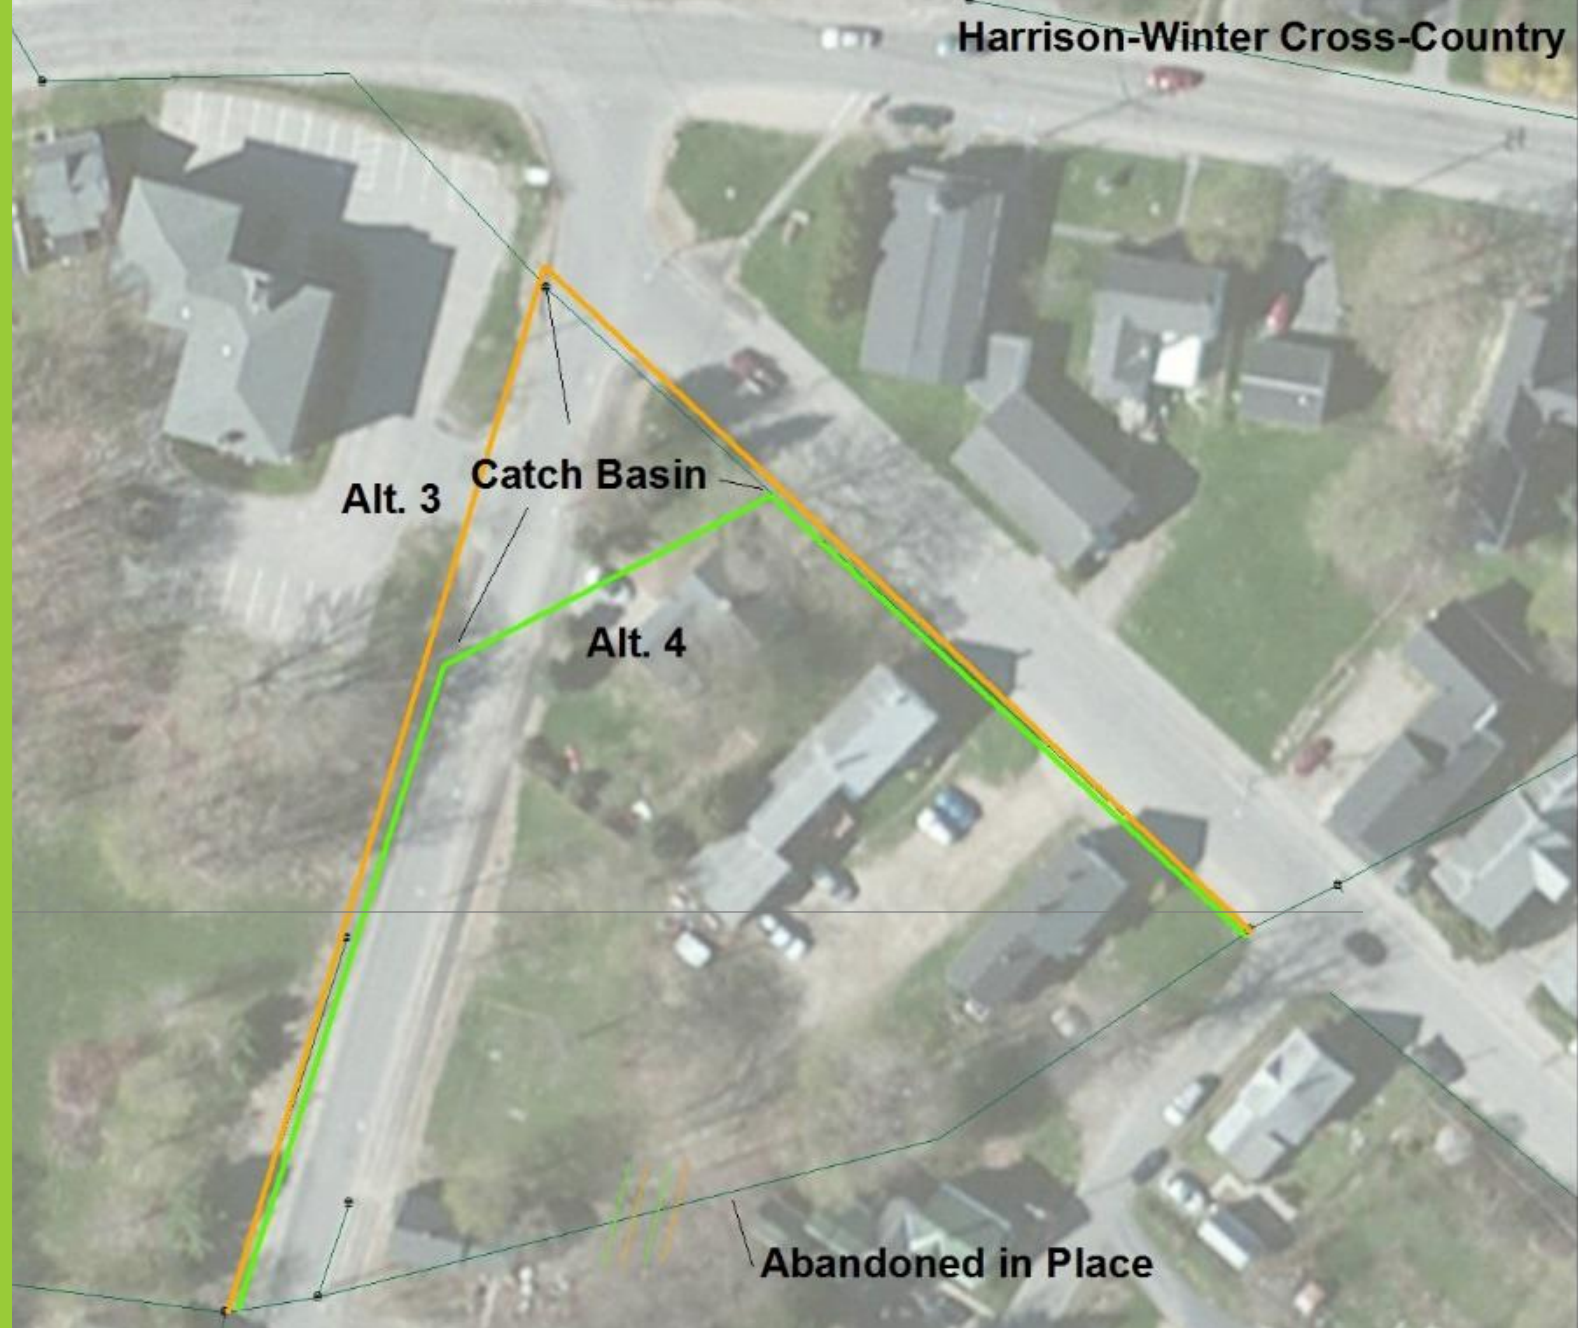
# Harrison to Winter Cross- Country Alternatives:

| Severity | | | | | | | | | | |
|---|---|---|---|---|---|---|---|---|---|---|
| 13 | 4 | Engineering | Deteriorated Piping | Reroute | 22 Harrison Avenue | Harrison | Fountain | 18 | N | Camera inspection of the cross-country line between 22 |

| | A | B | C | D | E | F | G | H | I | |
|---|---|---|---|---|---|---|---|---|---|---|
| 13 | 4 | Engineering | Deteriorated Piping | Reroute | | | Fountain | 18 | N | Camera inspection of the cross-country line between 22 |

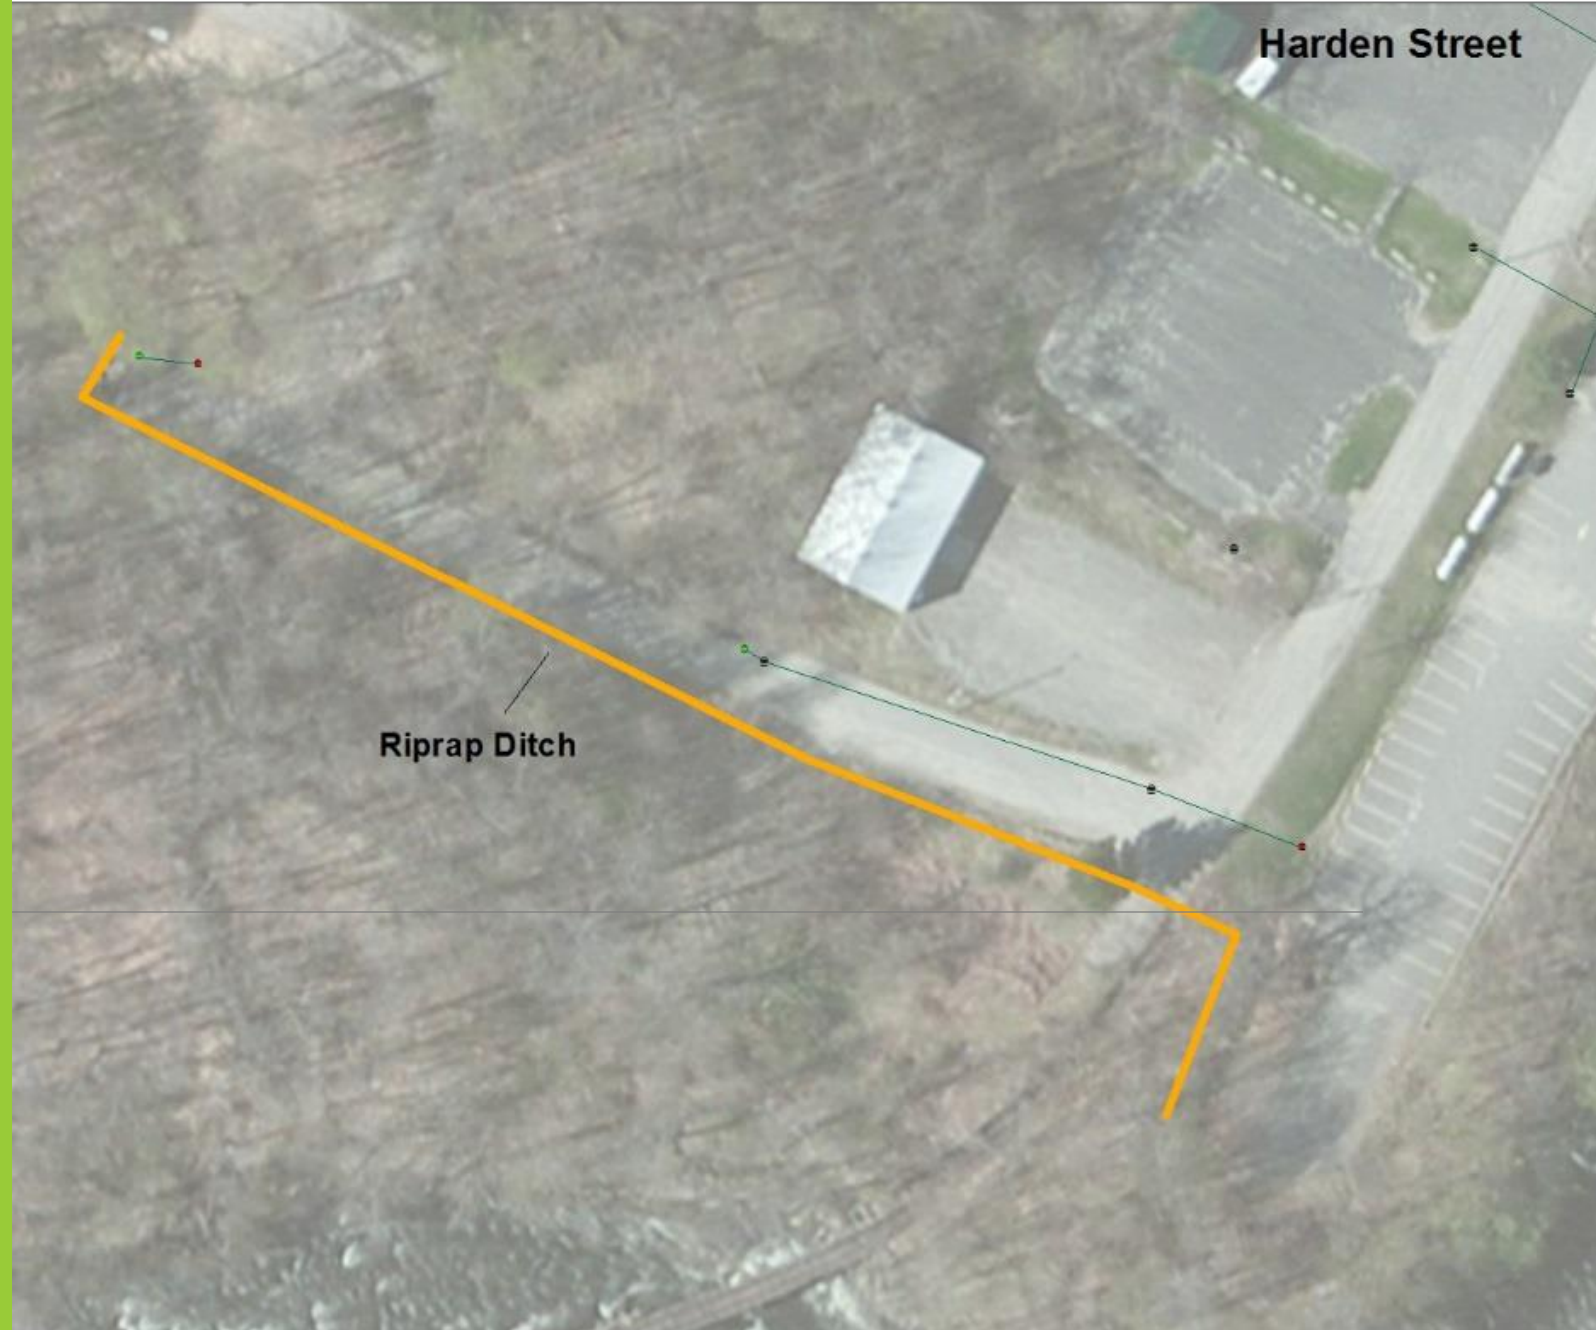
# Harden Street Improvements:

| Severity | | | | | | | | | | |
|---|---|---|---|---|---|---|---|---|---|---|
| 9 | 4 | Maintenance | Sediment Deposits | Clean | Harden Street | Harden | N/A | 21 | N | catch basins and piping on Harden Street packed with sed |
| 10 | 4 | Engineering | Sediment Deposits | Additional Infrastructure | Harden Street | Harden | N/A | 21 | N | Flooding from plugged catch basins have been reported c |

| Street | Repairs |
|---|---|
| Harden Street | Clean sediment deposits* |

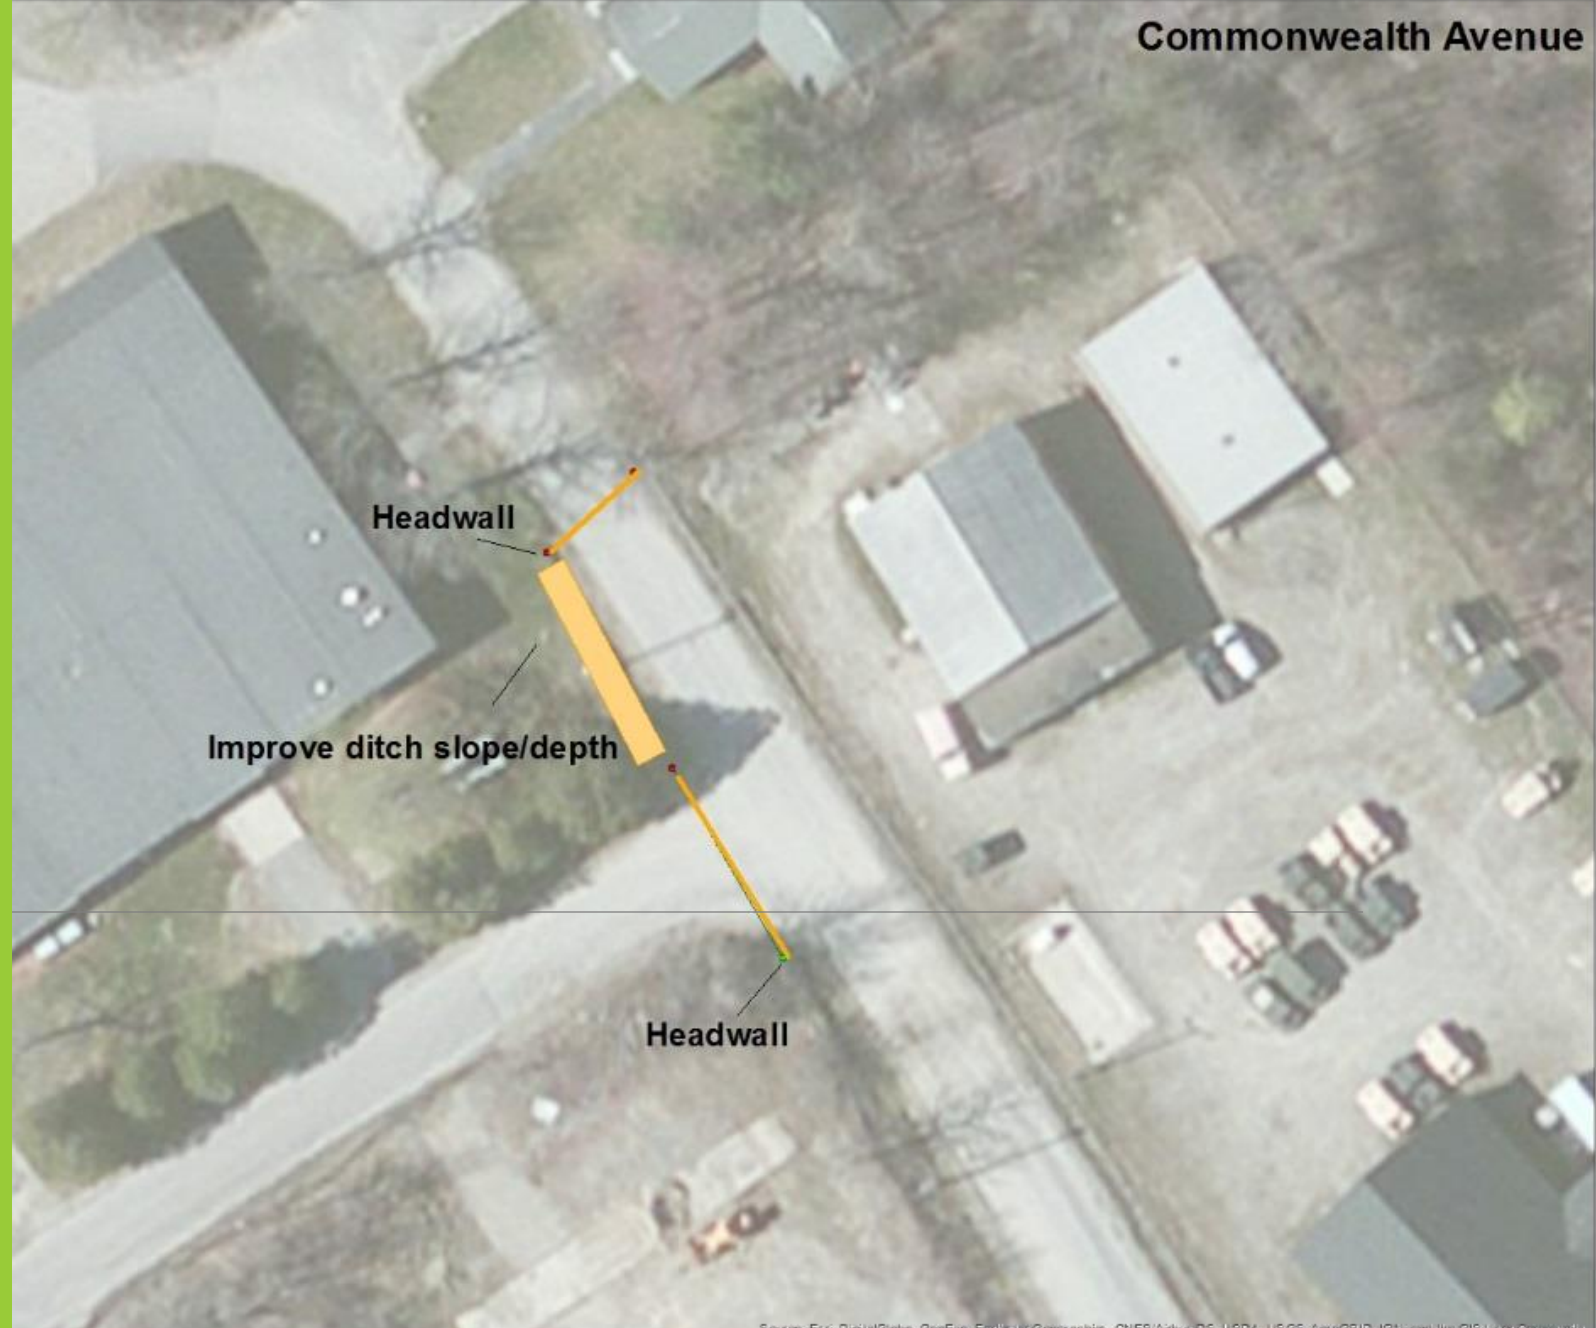
# Commonwealth Avenue Improvements:

| Severity | | | | | | | | | | |
|---|---|---|---|---|---|---|---|---|---|---|
| 4 | 4 | Engineering | Flooding | Redesign | Commonwealth Avenue | Commonwealth | N/A | 11 | Y | Flooding has been reported along Commonwealth Avenu |

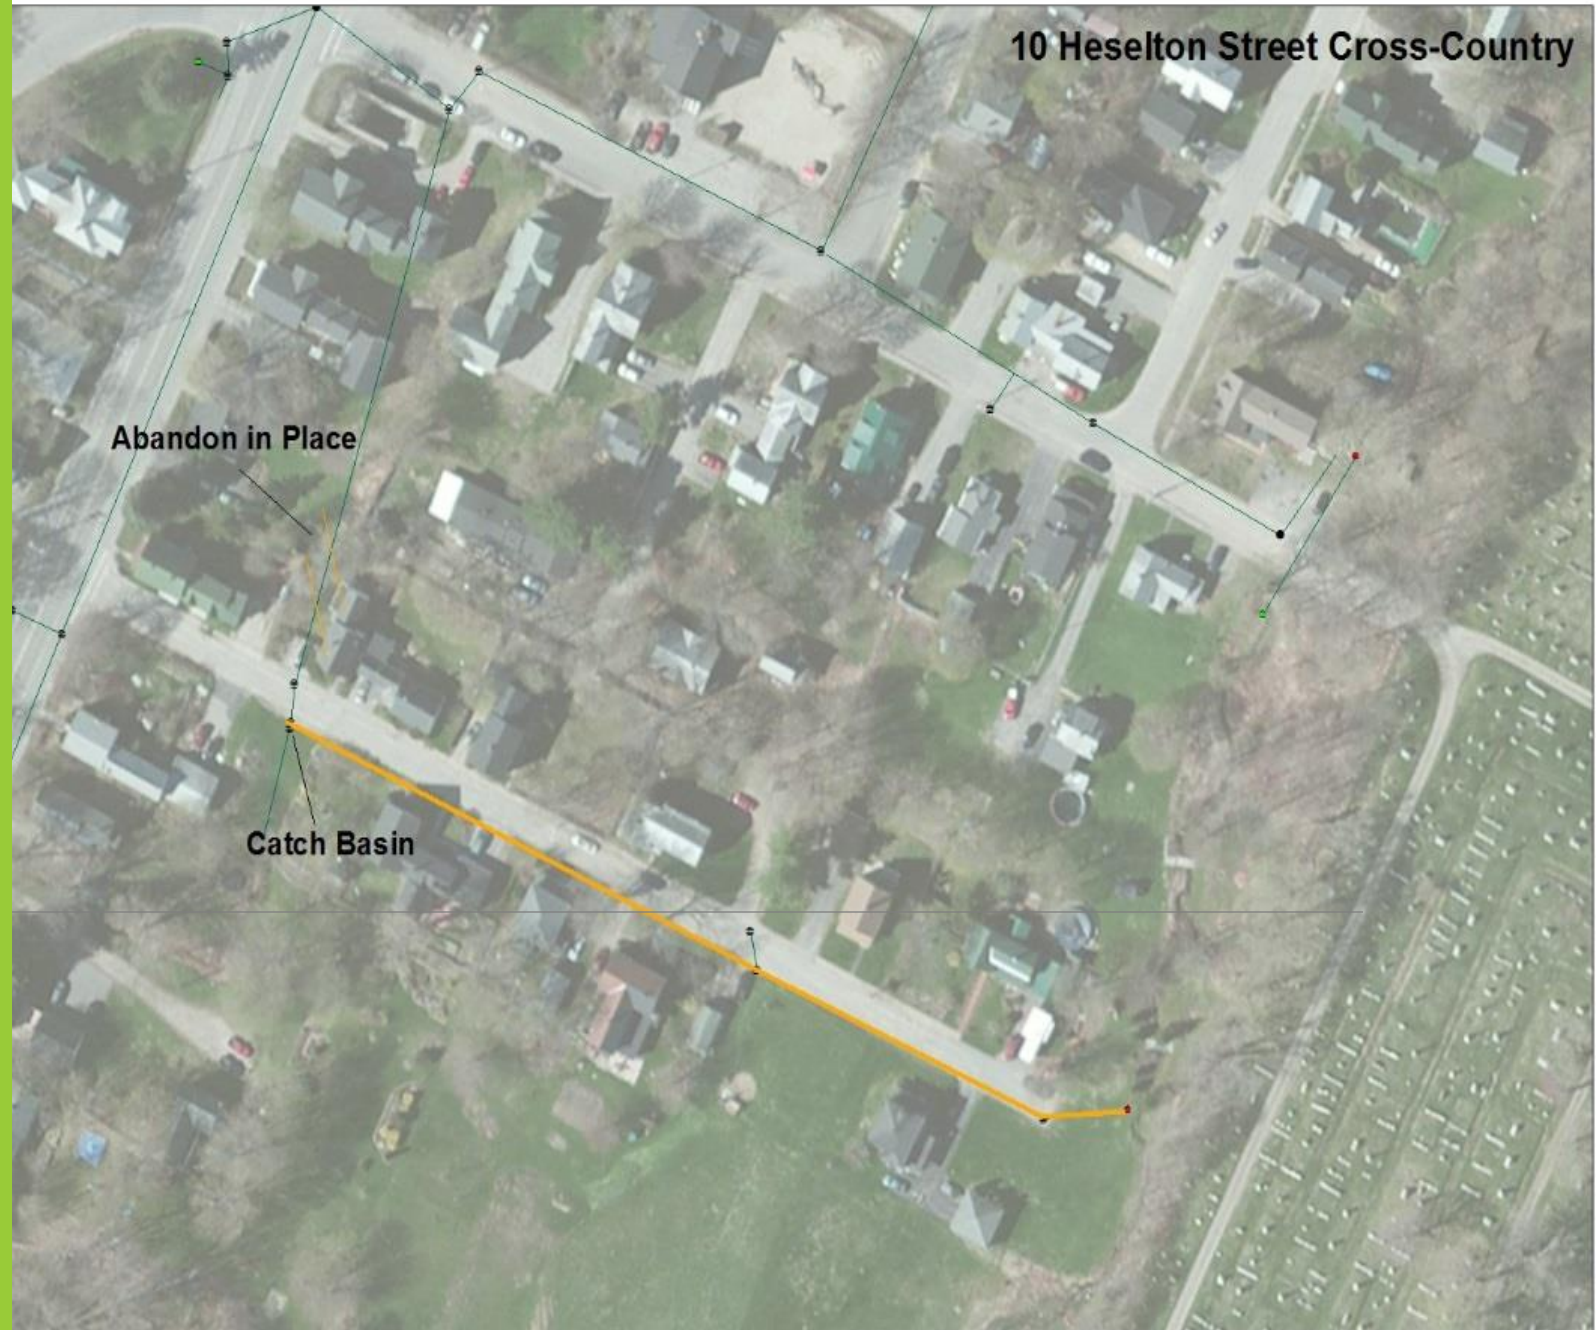
# 10 Heselton Street Cross- Country:

| Severity | | | | | | | | | | |
|---|---|---|---|---|---|---|---|---|---|---|
| 14 | 4 | Engineering | Flooding | Reroute | 10 Heselton Street | Heselton | Plummer | 4 | N | Flooding has been reported at catch basin in front of 10 |

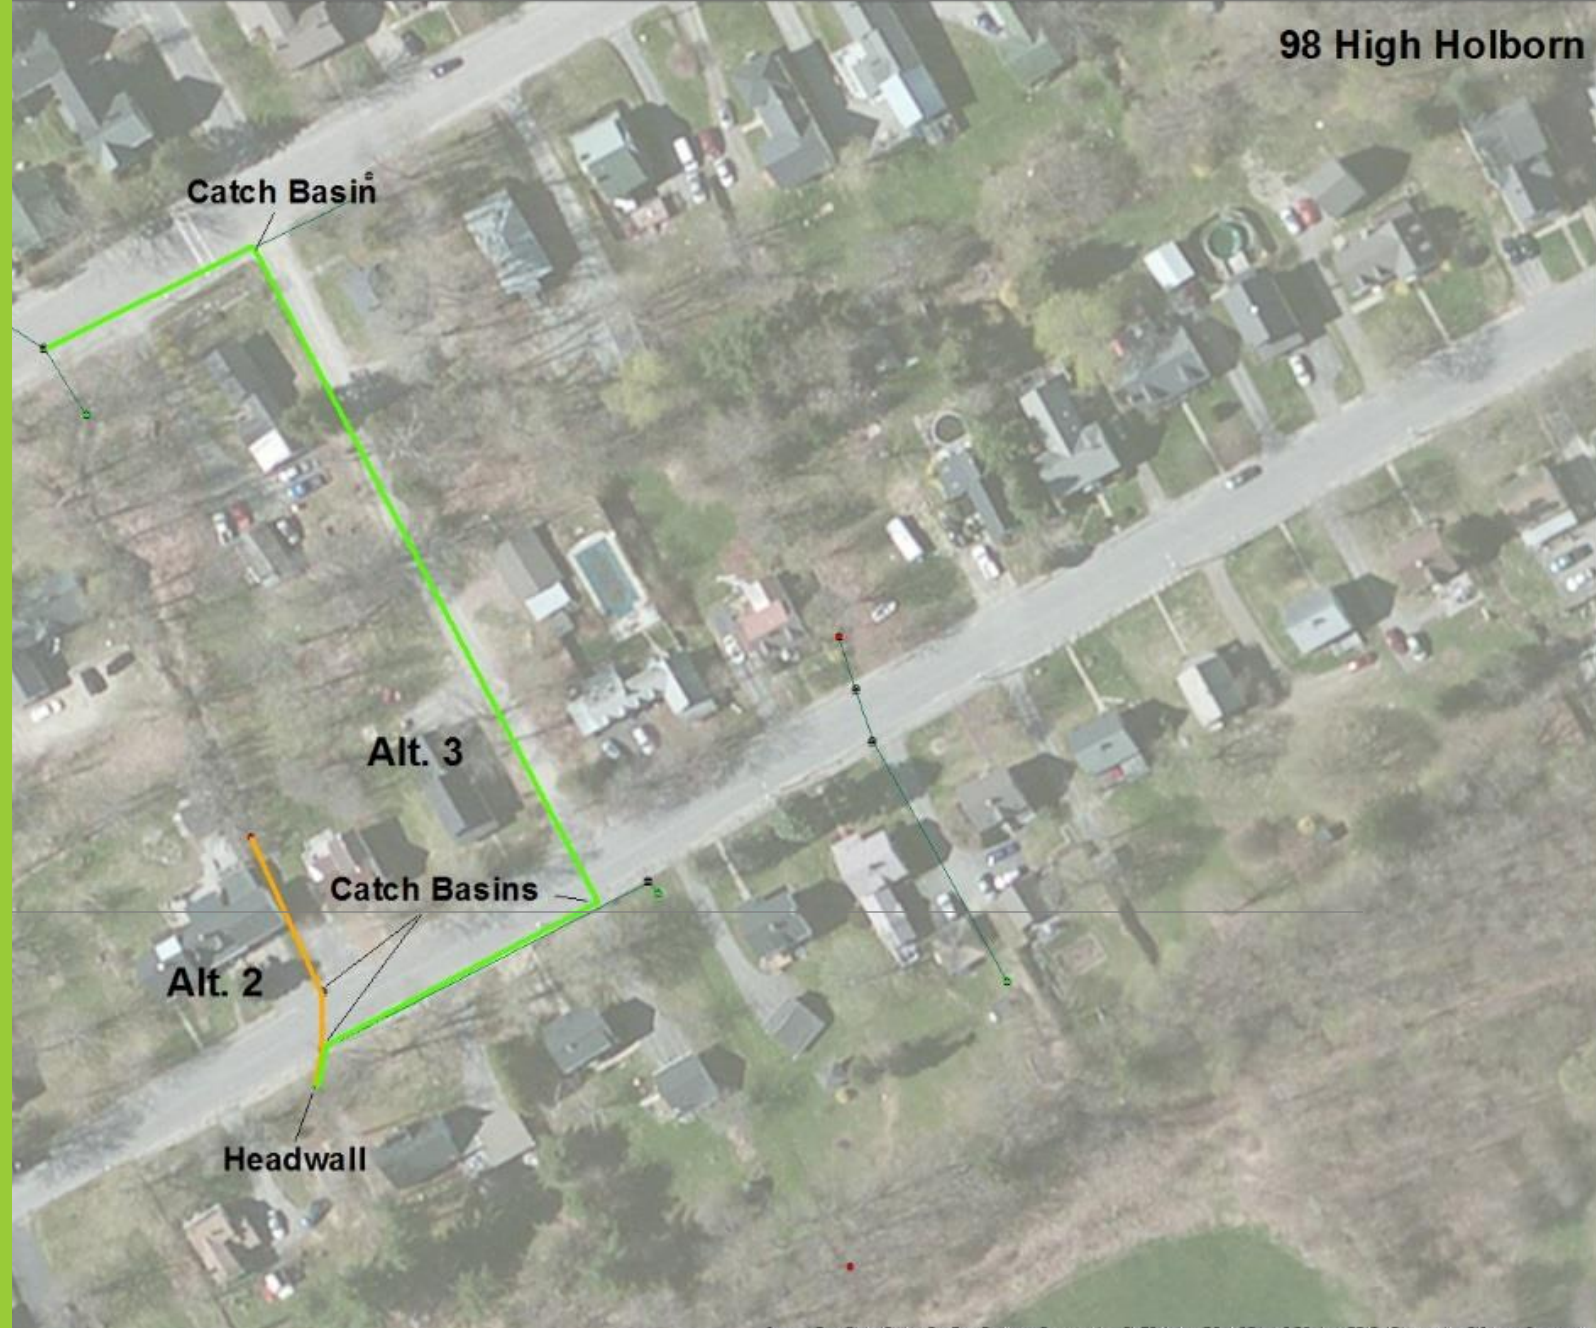
# 98 High Holborn Alternatives:

| Severity | | | | | | | | | | |
|---|---|---|---|---|---|---|---|---|---|---|
| 18 | 4 | Engineering | Flooding | Resize Pipe, Additional Infrastructure | 90 High Holborn Street | High Holborn | N/A | 11 | N | Flooding has been reported at the catch basin in front of |

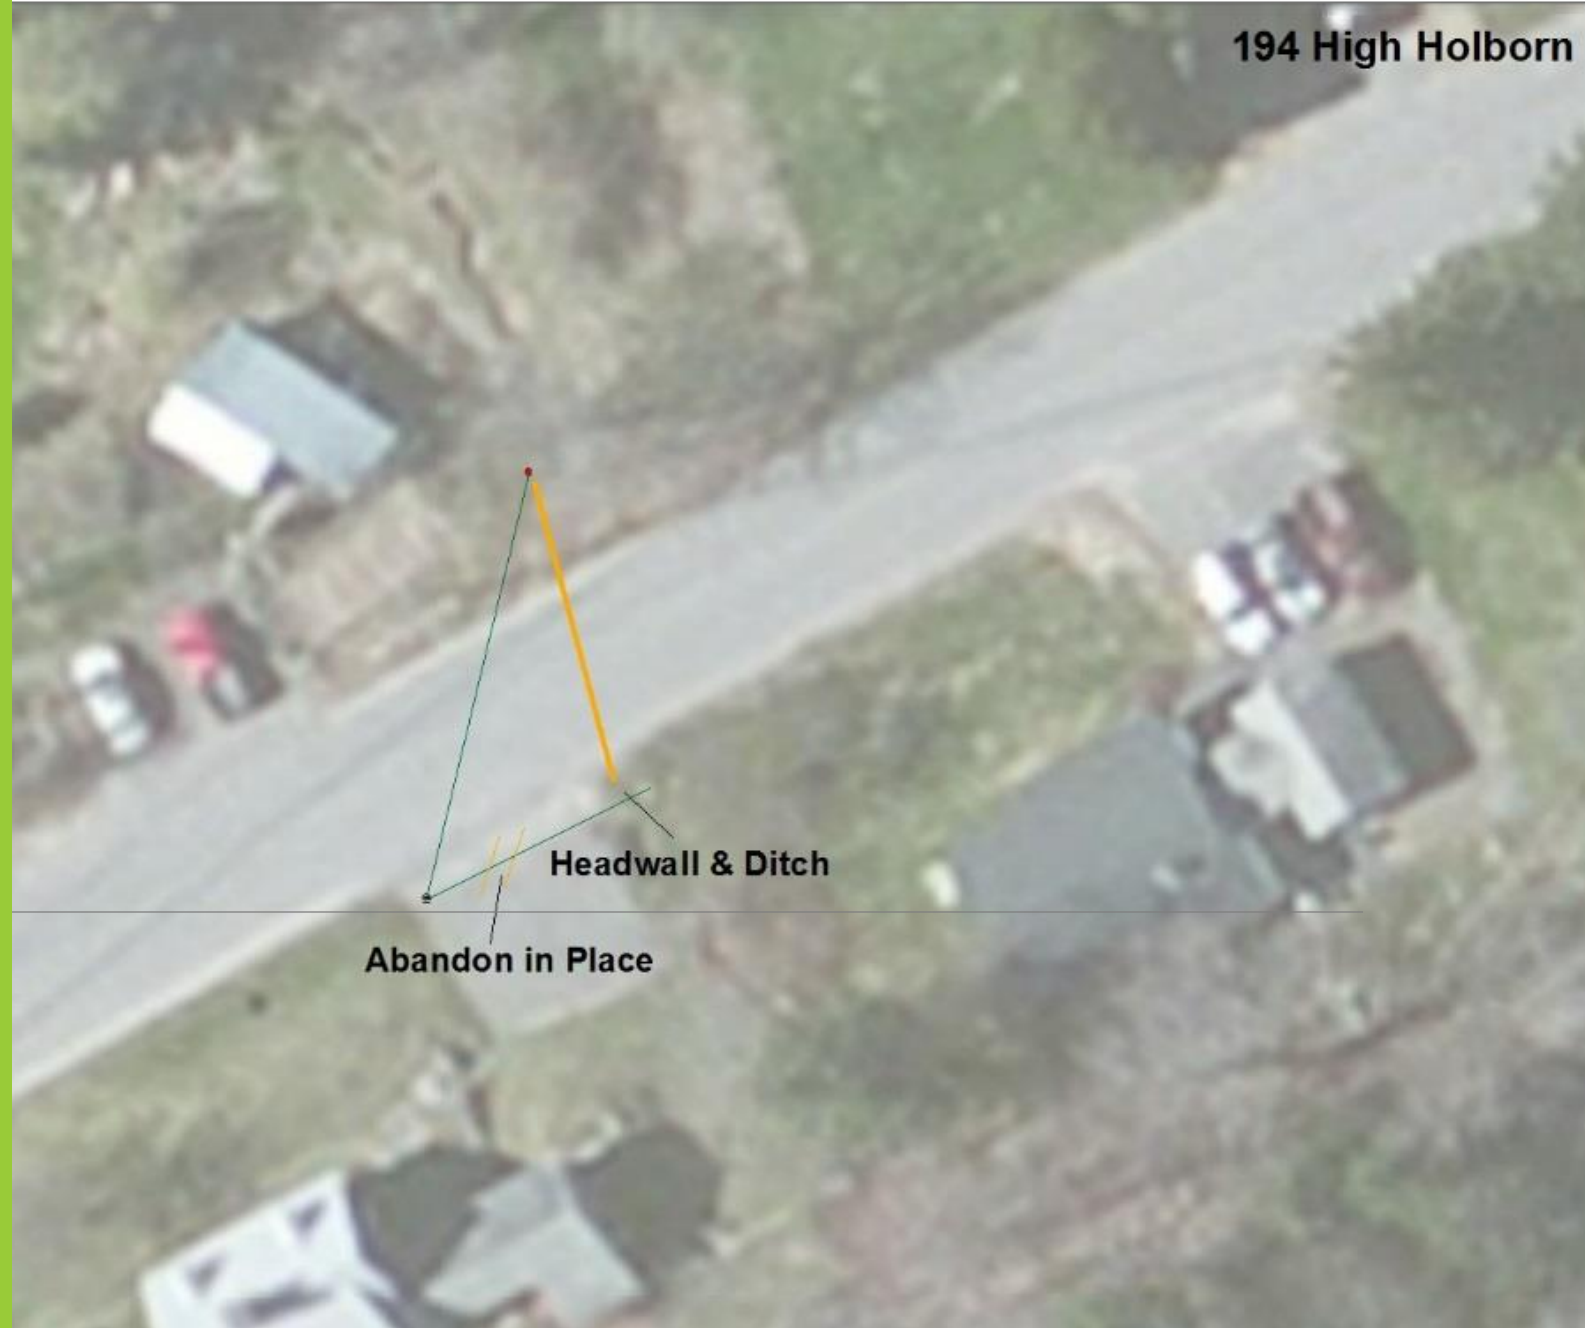
# 194 High Holborn Improvements:

| Severity | | | | | | | | | | |
|---|---|---|---|---|---|---|---|---|---|---|
| 17 | 5 | Maintenance | Catch Basin Deterioration | Replace | 194 High Holborn | High Holborn | N/A | 14 | N | At 194 High Holborn Street, the concrete around the rim |

| Street | Repairs |
|---|---|
| High Holborn Street | 194 – Replace deteriorated catch basin*<br>109 – Replace collapsed piping* |
