**GARDINER CITY COUNCIL
AGENDA ITEM INFORMATION SHEET**

Meeting Date	10/14/2020	Department	Buildings & Grounds
Agenda Item	4.m Consider Funding the Repair at City Hall/Fire Department		
Est. Cost	\$66,500

Project Quote
Generator Pad / Catch Basin & Drainage / Building Repair

Re: Mold Assessment at the above location.

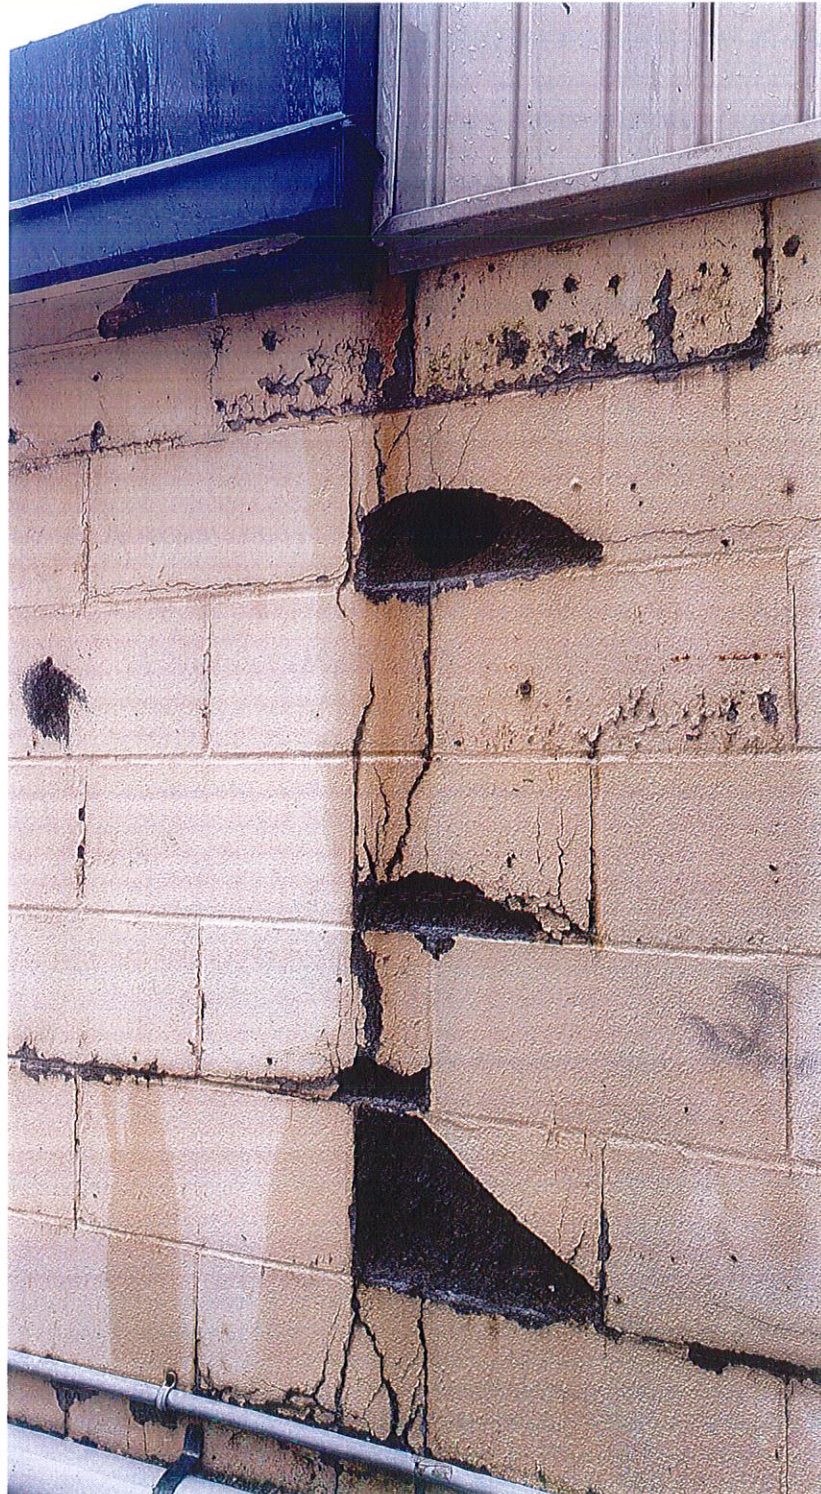
Site Location:
West Exterior Wall

We found that the CMU wall for the lower roof has experienced severe structural damage. The damage is being caused by water infiltrating into the surface of the CMU block when the roof water cascades down from the roof drip edge. Over the years, this water infiltration has deteriorated the surface of the block. When temperatures drop below freezing, the water within the block will freeze and expand, which will crack and separate the concrete off the surface of the block. Years of this deterioration along with freeze and thaw effects has resulted in the current damage consisting of large holes in the CMU (See Photo No. 1, 2, and 5). The damaged CMU is allowing water to enter the building causing leakage and unknown water damage. We found the remainder of the fire station rear CMU block wall has not experienced this same damage. This is due to fire station having internal roof drains and therefore not allowing water to cascade down the exterior of the wall.

Description:
Photo looking at exterior wall at the intersection of the main roof and the hose tower wall showing damage to CMU wall and wood soffit.

The rear wall of the fire station in the area of the lower roof is in very poor structural condition. We recommend replacing all of the damaged CMU wall in order to properly support the roof framing and provide a waterproof membrane to the exterior. The replacement of the wall framing can be with similar 8" CMU block framing reinforced at 32" on center, but the block will also need to be covered with metal siding in order to protect the block from future water damage. We also recommend installing a minimum of a 12" roof overhang in this area in order to direct water away from the wall surface. This will require replacing the EPDM roof in this area. The replacement of the wall will most likely expose unseen water damage in the wall, roof, and surrounding area including utilities that will need to be addressed.

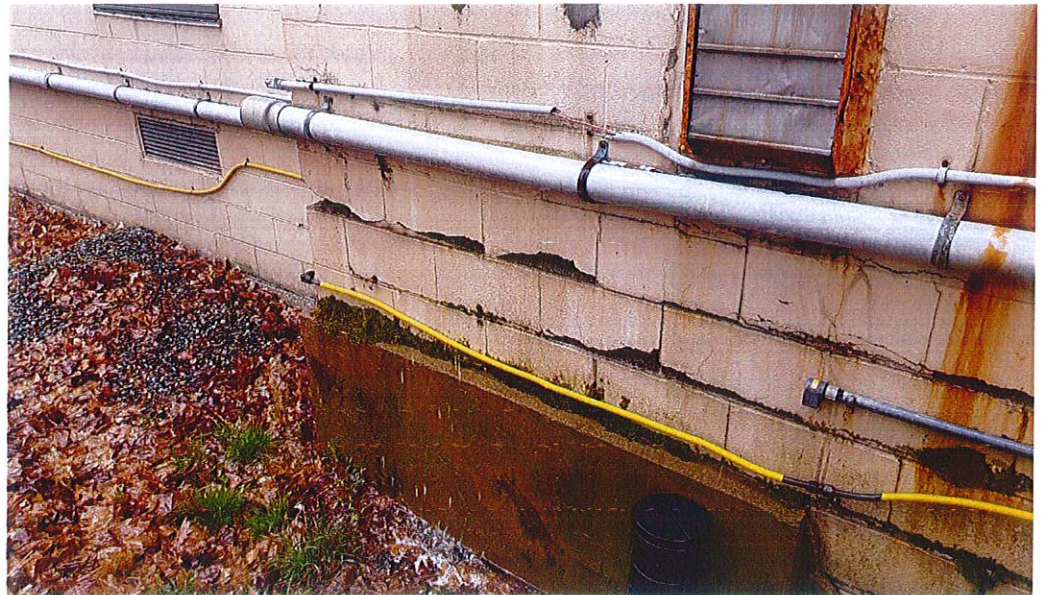
Site Location:
West Exterior Wall

Description:
Photo looking at the bottom of the exterior wall at the corner.

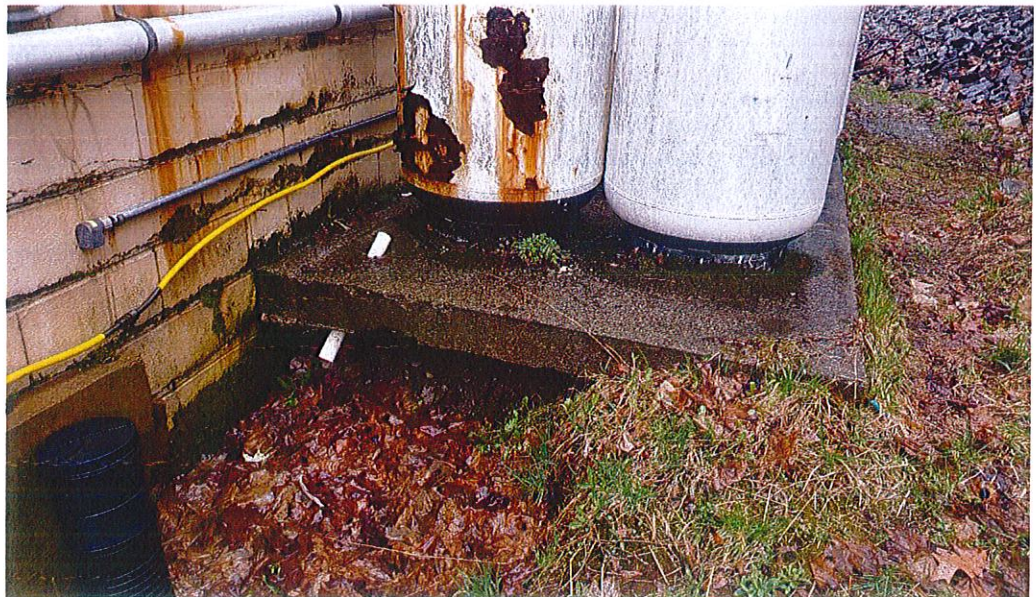
Photo No. 3

In the rear of the building, we also observed a slab on grade that has been undermined from the water coming off from the roof (See Photo No. 3). This has left the slab unsupported and relying on the rear CMU wall for support. In the same area, we found improper drainage for the water coming off from the

Description:
Photo looking at the bottom of the exterior wall and the undermining of the propane tank slab.

We recommend supporting the undermined concrete slab by forming an enclosure around the bottom of the slab opening and then pumping flowable fill through a hole in the slab to fill the void. We also recommend verifying that a drainage pipe has been installed at the rear of the building in the area of the accumulating water and then installing a field inlet that connects to the underground piping in order to drain the area.

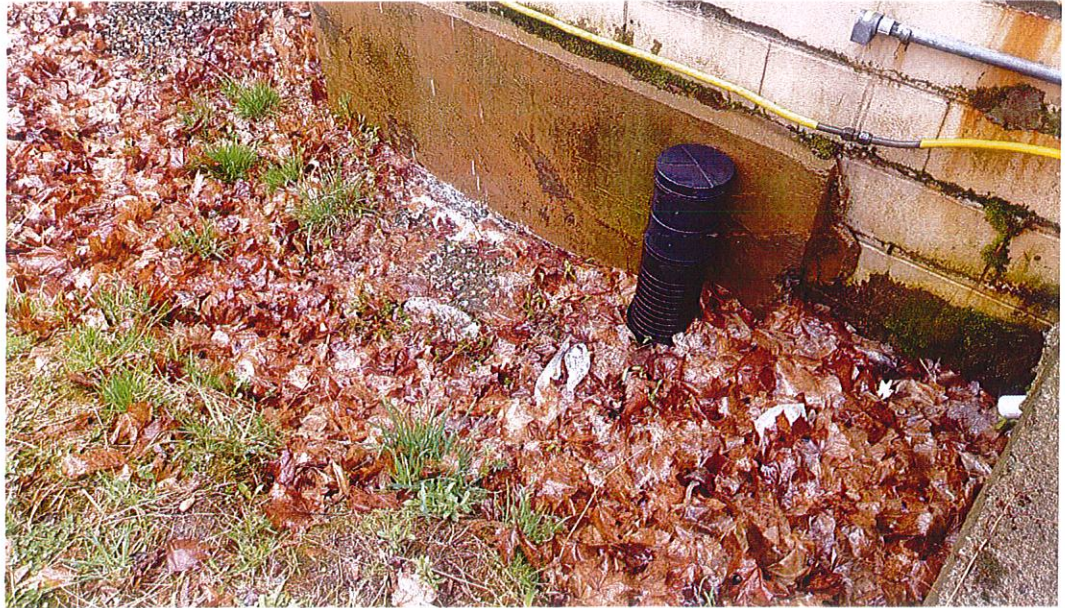
Site Location:
West Exterior Wall

roof (See Photo No. 4). We found a large puddle of water with no place to drain, but there is evidence of a recent pipe installation that may be able to provide drainage to the area.

Description:
Photo looking at the bottom of the exterior wall at the corner showing water accumulation.

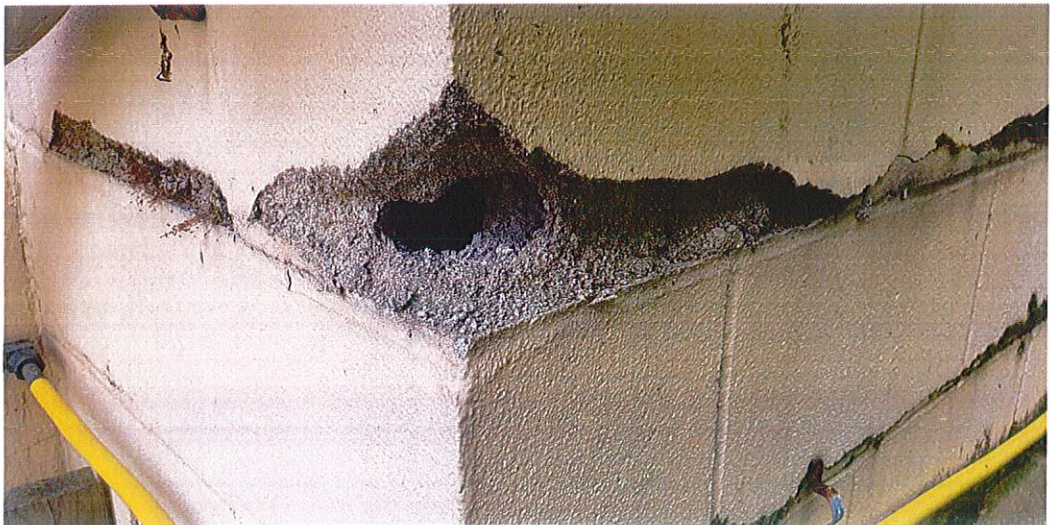
Photo No. 5

Description:
Closeup photo of a hole in the wall at the corner.

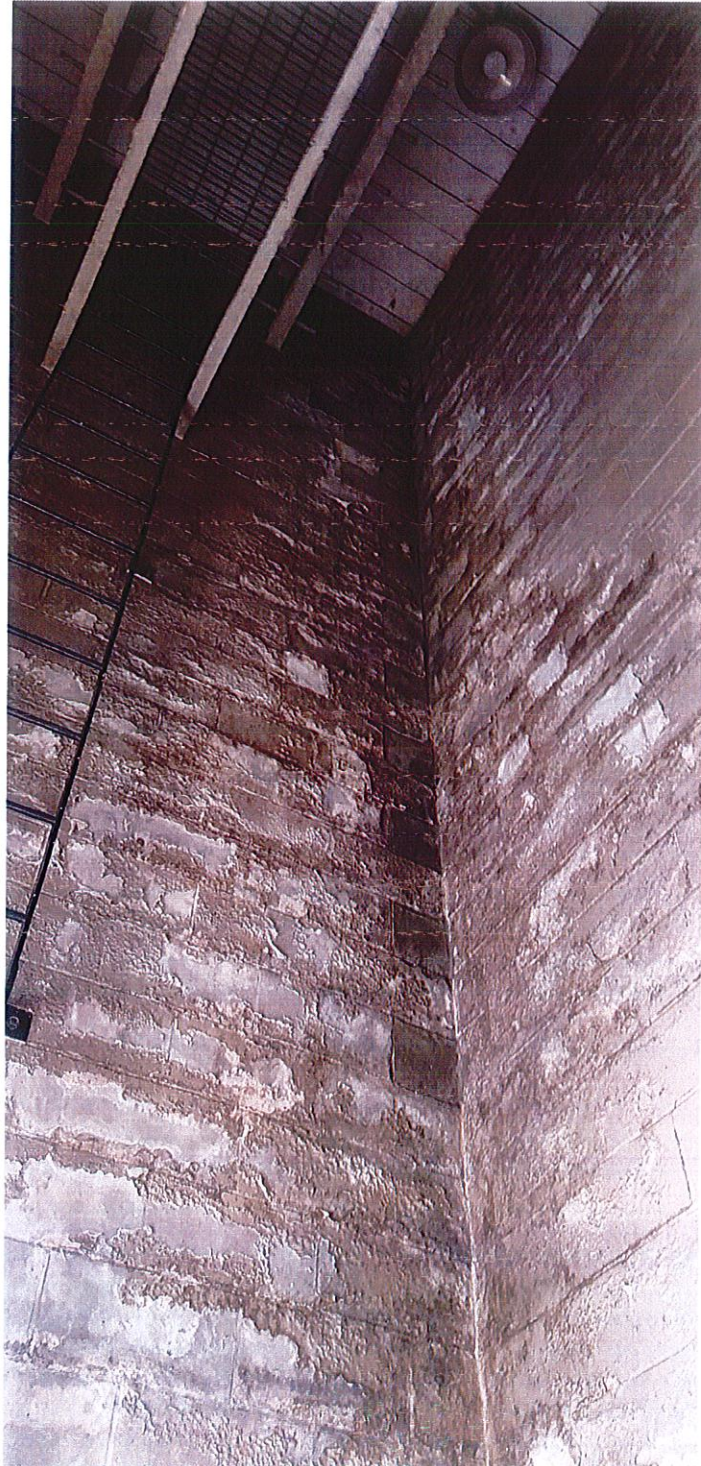
Site Location:
West Exterior Wall

We also observed that the lower roof abuts a hose tower that is constructed with the same CMU block, but the exterior has been covered with metal siding. We observed moderate water infiltration damage to the interior of the hose tower caused by the tower being subjected to windblown water over the years. At some point the City covered the exterior of the block wall with metal siding to in order to stop the infiltration and preserve the remaining CMU wall (See Photo No. 6).

Description:
Photo looking at the damage to the CMU wall in the interior of the hose tower.

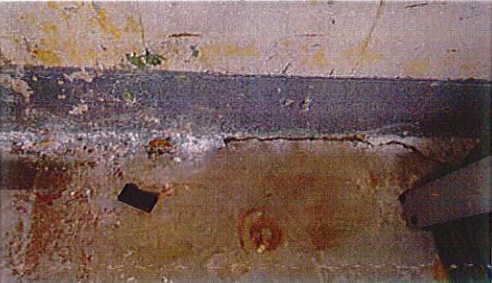
Signs of water infiltration through the back-side exterior wall in the Weight Room

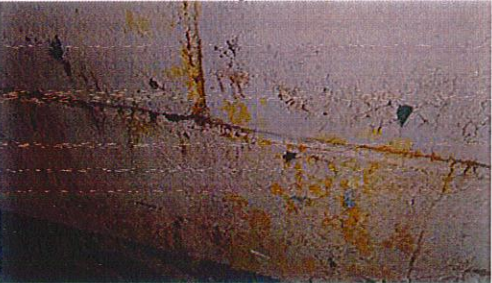
Signs of water infiltration through the back-side exterior wall in the Weight Room

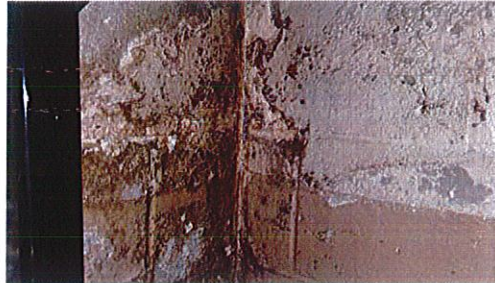
Signs of water infiltration through walls in the Hose Tower

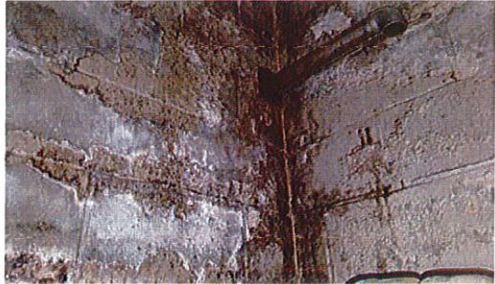
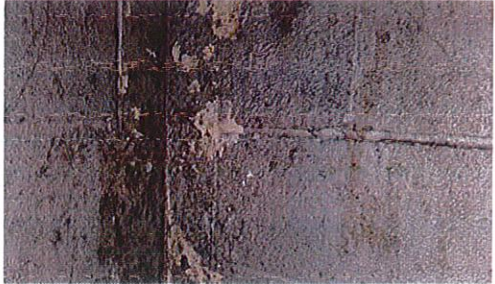
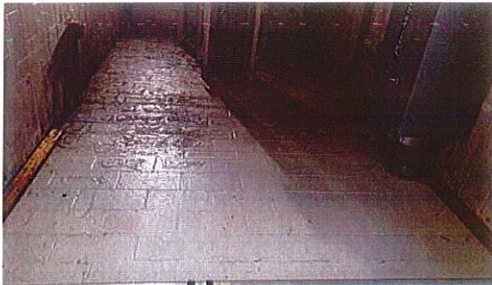
Mold growth and signs of water infiltration through walls in the Hose Tower

- Hose Tower and Weight Room – Clean / Treat (see Definitions) walls with signs of water infiltration and visible / suspected mold growth. An abrasive-media method (e.g. Soda or dry-ice blasting) may be necessary to remove mold on surfaces as well as impregnated in paint.

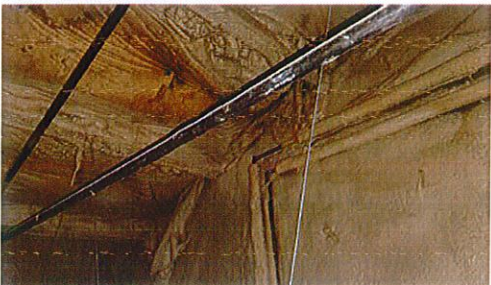
Roof systems do not direct water runoff wall-away from the foundation

- Replace building materials / Release Remediation area ONLY after a successful post remedial evaluation.
- Consult a Professional Engineer or a competent qualified contractor to control groundwater intrusion through perimeter walls and/or prevent saturated soil surrounding the foundation by: installing exterior foundation perimeter drainage, sloping the ground away from the foundation 5% (6" for every 10'), installing gutters (If gutters are to be installed ensure they are kept free of debris and the downspouts direct water well-away from the foundation), and water proofing the foundation walls or utilizing other like systems.
