Original: October 15, 2021
 Add Maine Law: November 8, 2021

Re: **Structural Evaluation of Existing Building**
 Downtown Row Block
 235 Water Street
 Gardiner, ME 04345

PROJECT TYPE
BUILDING EVALUATION

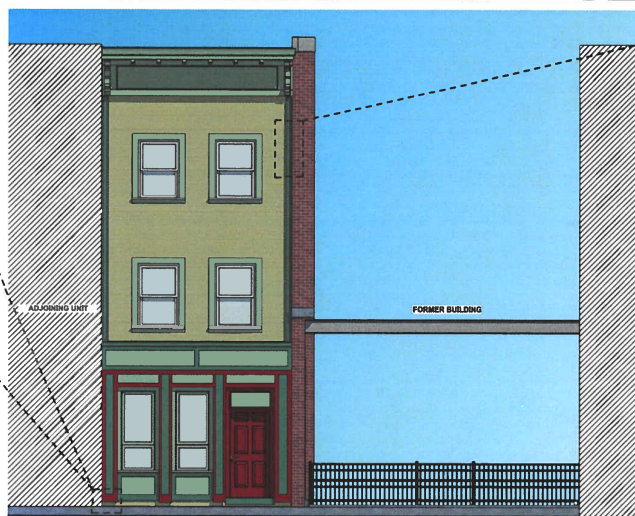
FRONT ELEVATION 1
NOT TO SCALE A200

PHOTO 1
FALSE FRONT AT WATER STREET
NOTE VISIBLE GAP TO THE EXTERIOR

PHOTO 2
FALSE FRONT AT WATER STREET
NOTE VISIBLE GAP TO THE EXTERIOR

PHOTO 3
FALSE FRONT AT WATER STREET
NOTE VISIBLE GAP TO THE EXTERIOR

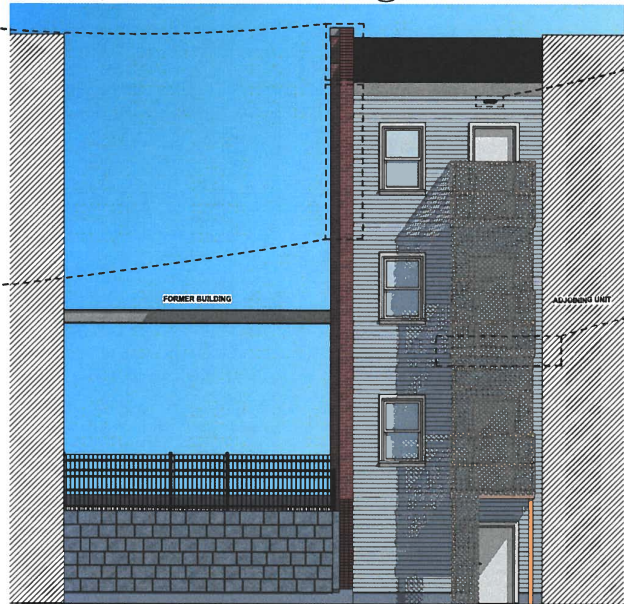
REAR ELEVATION 2
NOT TO SCALE A200

PHOTO 6
CLOSEUP VIEW OF REAR EXTERIOR BEARING WALL
NOTE CONDITION OF WALL FRAMING AND LACK OF WALL SHEATHING DUE TO FIRE

PHOTO 7
VIEW OF NORTHEAST CORNER OF BUILDING UNIT
NOTE MASONRY WALL IS SEPARATING FROM WOOD FRAMED STRUCTURE.

PHOTO 8
VIEW OF FIRE ESCAPE LEDGER ATTACHMENT
NOTE CONDITION OF REAR WALL NEGATES THE STRUCTURAL CAPACITY OF THIS ATTACHMENT

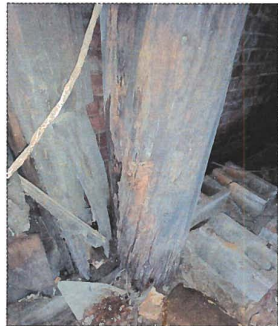
PHOTO 8
DRY ROT LOG SUPPORT POST
