# CITY OF GARDINER

## CERTIFICATE OF APPROPRIATENESS APPLICATION/NOTIFICATION FORM

APPLICANT'S NAME: Andrew Molloy PHONE#: 207 221 5135  
MAILING ADDRESS: 226 Water St Halliwell MAP/LOT: 037-130  
PROPERTY LOCATION: 221 Water St ZONING DISTRICT: TD  
PROPERTY OWNER'S NAME: Andrew Molloy PHONE#: 207 221 5135  
MAILING ADDRESS: same  
NATURE OF REQUEST: renovate storefront back to historic configuration

## 219-221 Water Street Historic Rehabilitation Narrative

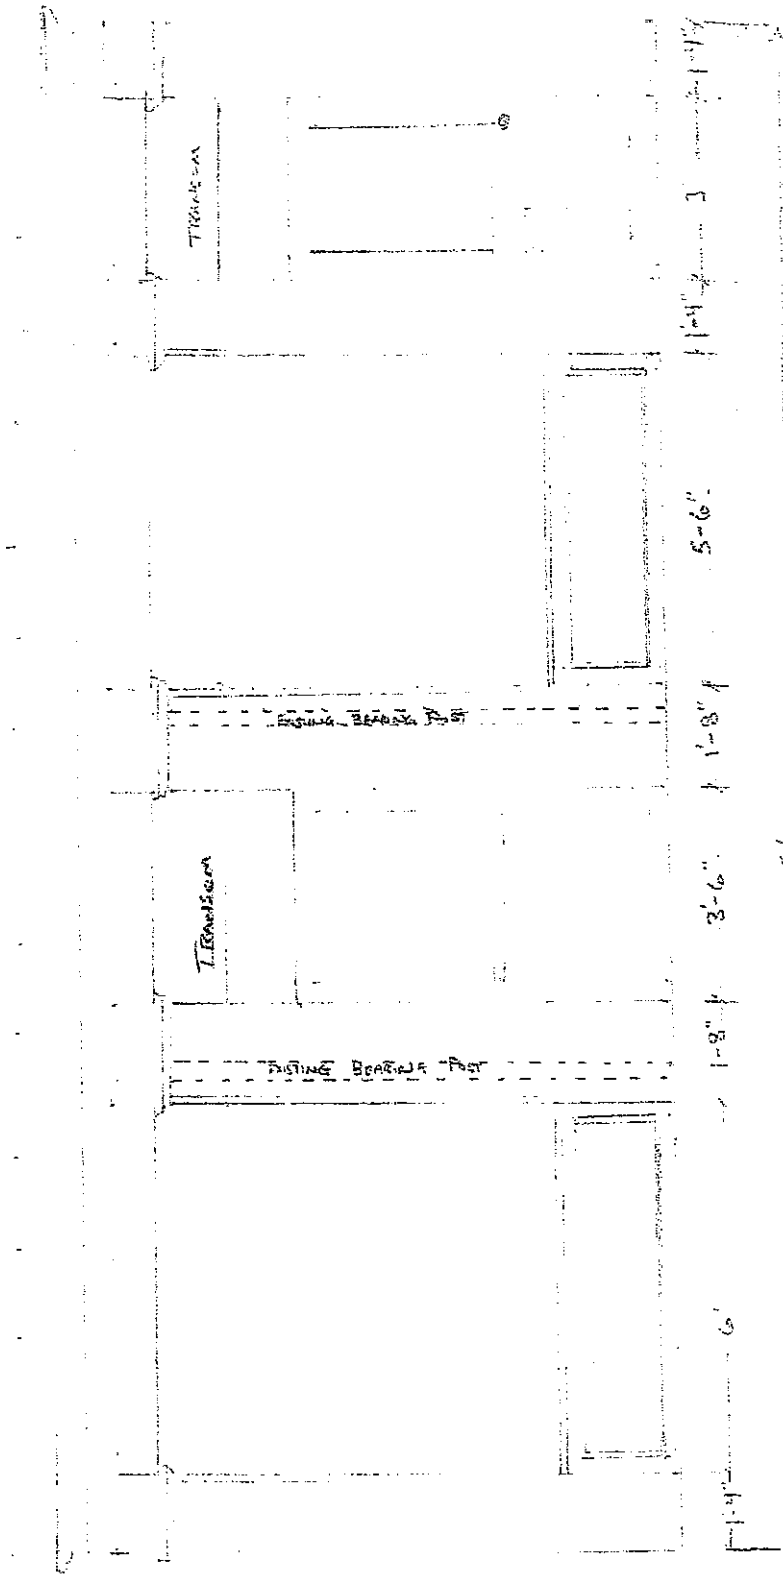
MAIN ENTRY DOOR

1-1'

2.) A wall will be erected in the interior before excavating the threshold and commencing demolition. Once exposed, the measurements of the threshold's dimensions will dictate the width of the door, which is estimated to be approximately 3'6" with a 3'10" opening at the sidewalk. The distance between the sidewalk and the lip of the granite threshold is approximately three feet. Once restored, the square, recessed entrance will extend from the door resting atop the lip of the threshold to the sidewalk. A door will be constructed based upon the threshold's dimensions that is a historically accurate reproduction of a mercantile/commercial entrance with a single pane at approximately the same height. The transom will be re-installed above the glass door at 221 Water Street along with the transom above a new, historically accurate door installed at the entrance of 219 Water Street. The transoms will be stenciled with the digits "221" and "219" respectively.
